MARCH 2022

TROUBLE SHOOTING GUIDE

A thorough guide for the causes, repairs and prevention methods of common application problems that occur in waterproofing and flooring systems

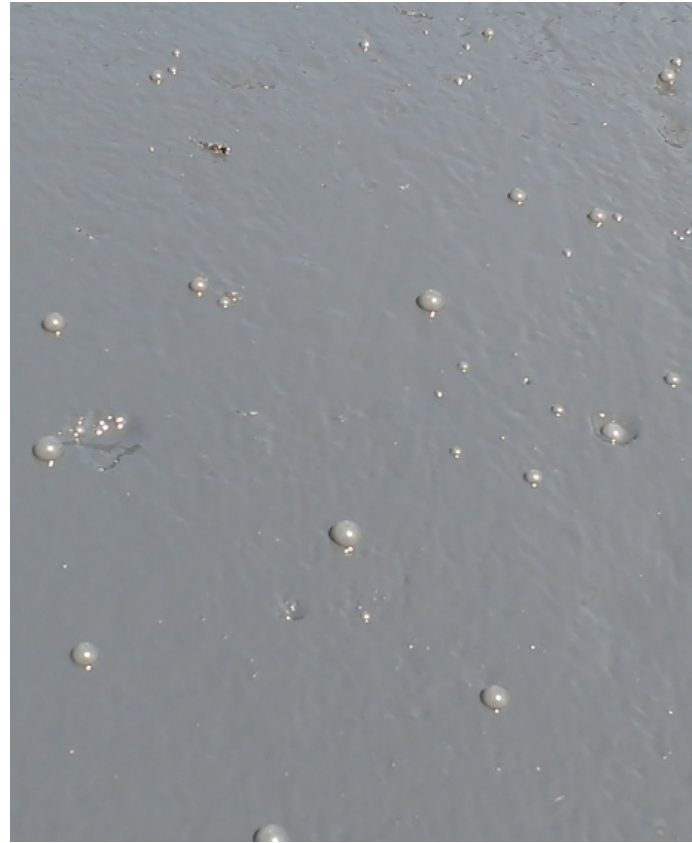
PINHOLES/ OMEGA HOLES

Pinholes or omega holes are holes on concrete surfaces that may cause blisters or bubbles once the membrane is applied. When these bubbles pop, they usually leave a round crater and the pinhole is seen through the film. Although ALCHIMICA's waterproofing membranes are developed to minimize this phenomenon, it is likely that it may occur depending on substrate conditions and temperature.

Concrete releases air and moisture vapor that expands as temperatures rise. Also, aggressive shot-blasting may open concrete pores and bug holes.

1. Break the blisters/bubblers before additional coating is applied.
2. Clean surface and solvent wipe if necessary.
3. Use HYPERSEAL®-EXPERT-150 or other ALCHIMICA® sealants to repair the crater area.
4. Apply the next layer of the waterproofing membrane.

Apply the appropriate ALCHIMICA® primer to effectively stabilize and seal the substrate.

Begin application as temperatures are dropping and continuing to drop. Rising temperatures result in expansion of the moisture and air in the concrete. Falling temperatures cause the air and moisture to contract within the concrete.

Apply the specified system in thinner coats, which will require more coats to build the system. Thinner application may displace the air in the pinholes.

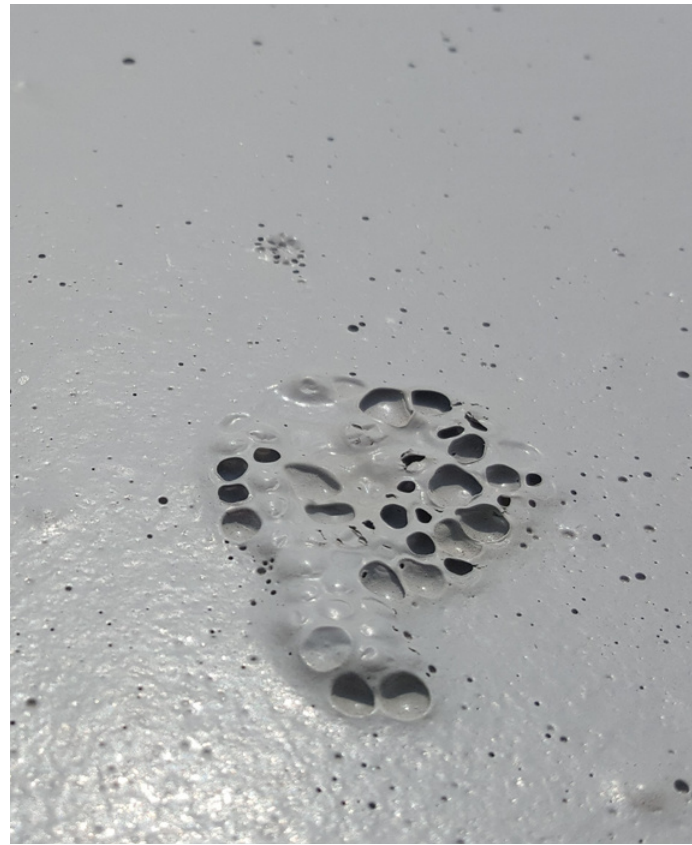
CRATERS DUE TO MOISTURE CONTAMINATION

Craters due to moisture can occur while a polyurethane membrane is applied/curing.

Moisture from relative humidity or moisture contaminated aggregates will react with the coating material and cause a bubbling effect as shown above. This is caused by a chemical reaction between moisture and the polyurethane coatings.

1. Grind smooth the affected areas.
2. Clean surface and solvent wipe if necessary.
3. Apply additional coating to match adjacent areas. If the coating is older than 1 week apply the primer MICROSEALER-50 at a consumption of 50-60gr/m².

Ensure that the deck is completely dry before applying the main membrane.

Conduct a moisture test before coating application to ensure that there is no contamination. Moisture may not be readily apparent.

If silica sand aggregates are to be used make sure they are dry as it can be a source of moisture contamination.

Ambient temperature should be more than 3°C above dew point. Relative humidity should not exceed 85%.

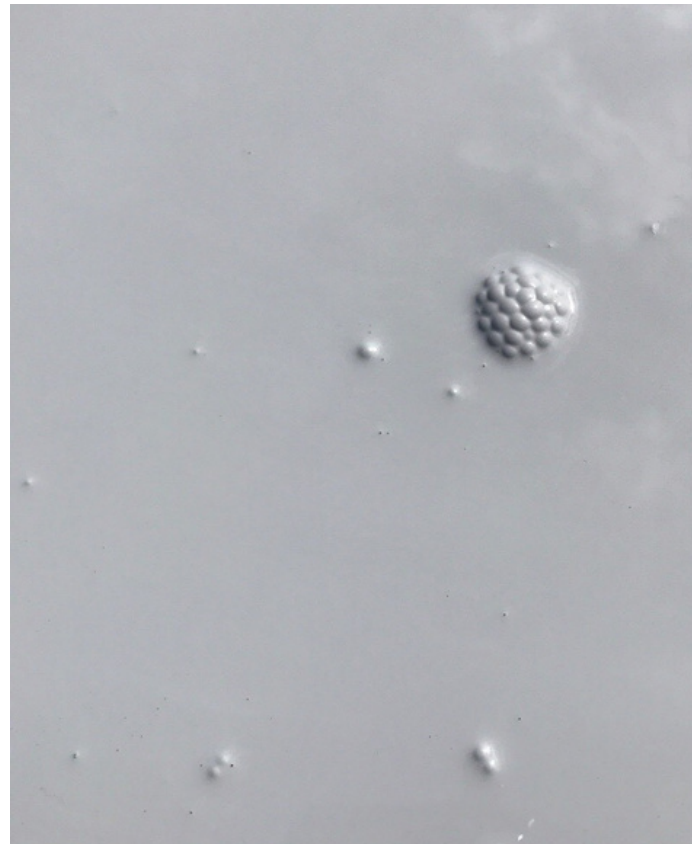
BLISTERING DUE TO WATER CONTA- MINATION

Blisters look like bubbles in the coating surface. The blisters will have a trace of water or moisture trapped inside them. Moisture between the wear coat and topcoat leaves an orange peel texture on the backside of the blister.

Water from rain, dew or other sources, mixed or rolled into wet/uncured product. Polyurethane coatings react with water and attempts to cure on the surface, forming blisters and stress wrinkled areas.

1. Cut out and remove all blistered and wrinkled areas.
2. Grind affected areas to sound coating.
3. If the coating is older than 1 week apply the primer MICROSEALER-50 at a consumption of 50-60gr/m².
4. Re-apply coating as needed to bring system to specified thickness.

Do not apply coating if rain is imminent.

Ambient temperature should be more than 3°C above dew point.

Ensure that the deck is completely dry before coating. Moisture may not be readily apparent. Conduct a moisture test before application to ensure that there is no water contamination.

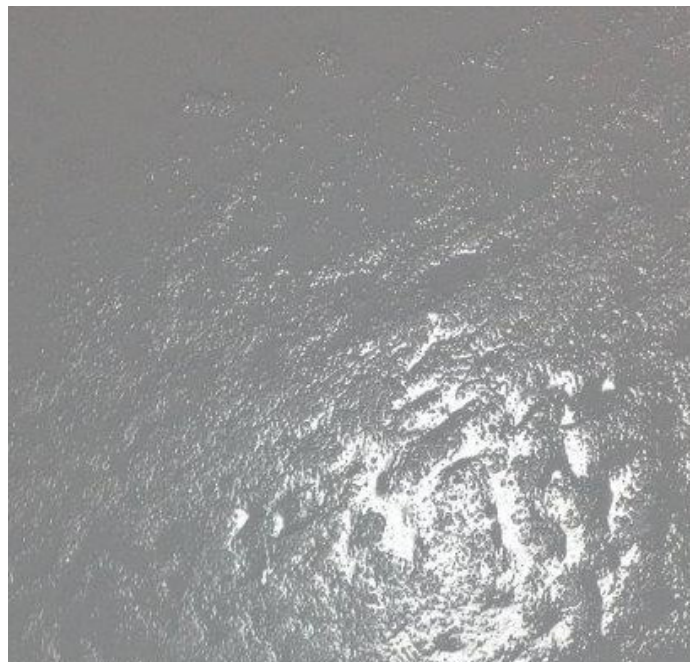
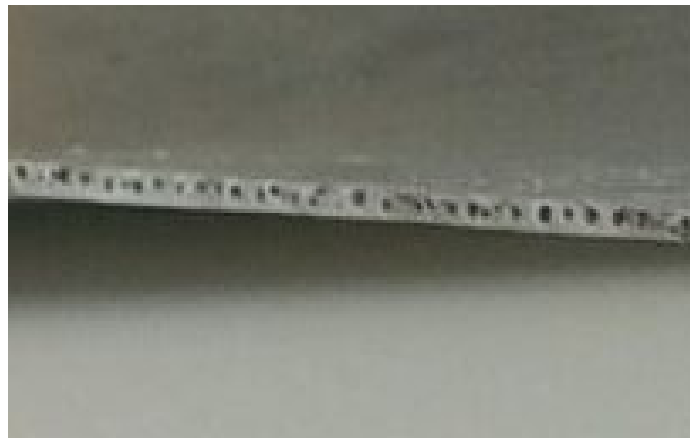
BLISTERING DUE TO THICK COAT APPLICATION

Blisters look like small to large unbroken bubbles in the coating surface and can appear round. The coating may give an orange peel texture.

Coating was applied at a rate higher than application instructions.

1. Completely remove affected areas down to cured coating or substrate.
2. Reapply the product according to its instructions.

During installation of coating, frequently check the wet film thickness.

Laying out the job prior to coating by gridding out the area will help to maintain proper and uniform coating thicknesses.

During application, back roll to eliminate low spot areas where self-leveling coating may pool.

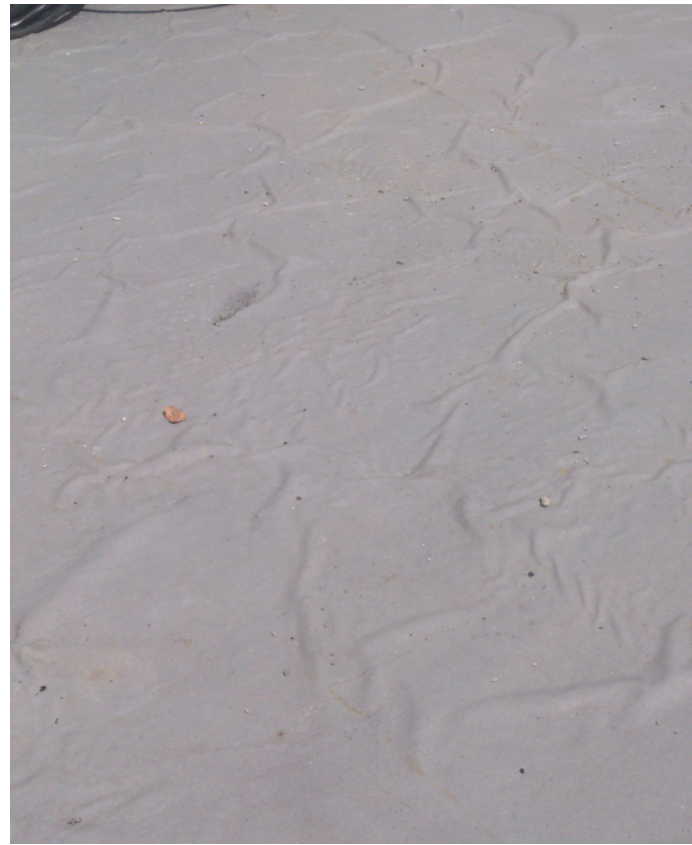
WRINKLING

Coating is wrinkled in appearance. Multiple lines of parallel wrinkling may occur.

Material applied over uncured primer or coating, causing stress on the topcoat.

Coating applied at a thickness that exceeds application instructions.

Coating has lost adhesion due to missed adhesion window.

1. Remove coating in affected areas to cured coating or sound substrate
2. Reapply the product according to its instructions.

Ensure that primer or previous coats are completely cured before applying additional coats.

Coating Too Thick: Apply coatings at recommended coverage rates.

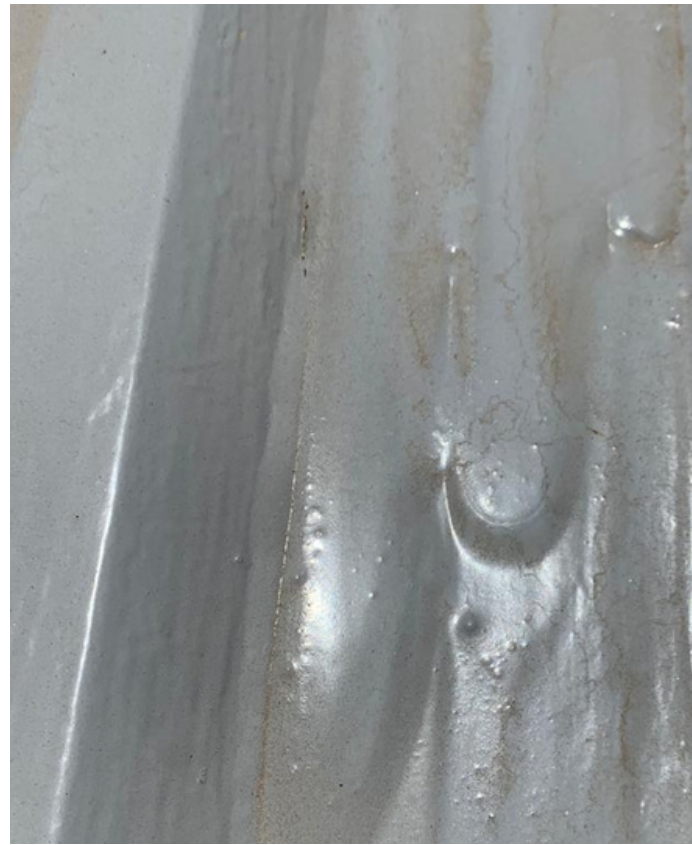
SLOW CURE OR NOT CURING

Coating is soft and may transfer when touched. Coating may also delaminate.

Product has been diluted with a non-suitable solvent. Generally, the coating will feel tacky, but in worst-case scenario the coating will remain in a liquid state.

Product applied in very low temperatures.

1. Remove to sound, clean substrate.
2. Solvent wipe to remove all residue. Grind to sound concrete if necessary.
3. Re-apply system.

Do not use other products than ALCHIMICA® SOLVENT-01 in order to dilute the products.

Apply the products within the specified application temperature range.

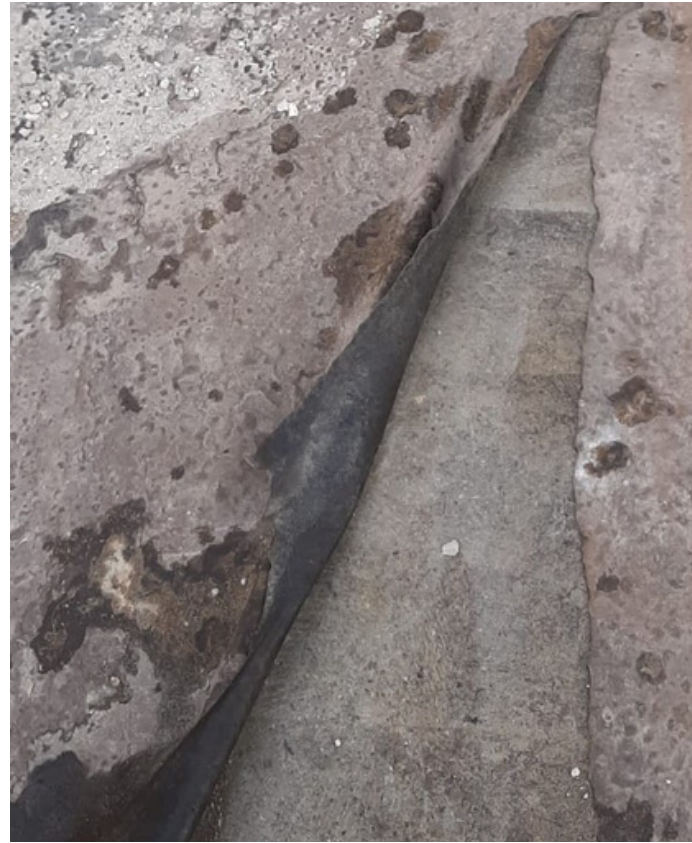
PEELING/ DELAMINATION ON SUBSTRATE

Coating may peel off in places and show signs of concrete laitance or other contaminants on the backside.

Surface was not shot-blasted or abraded prior to applying membrane, or the base coat was applied over epoxy primer after the 24-hour window.

There was dew or other moisture on the surface that was coated.

Coating over contaminated surfaces will lead to coating failures such as loss of bond.

Materials that are incompatible with the coating will cause many issues including delamination.

- 1.Remove all loosely bonded material.
- 2.If substrate is exposed, abrasion may be necessary.
- 3.Clean repair area.
- 4.Re-apply the system as specified by ALCHIMICA®.

Substrate should be cleaned prior to primer application. Determine substrate particularities and consistency and choose the right primer as displayed in the ALCHIMICA® Primer Selection Table

Ensure deck is clean and dry prior to application of material.

Incompatible Materials: Perform field adhesion test prior to application of the coating when installing coating over existing coating system.

Apply the system at specified rates and per ALCHIMICA® recommendations.

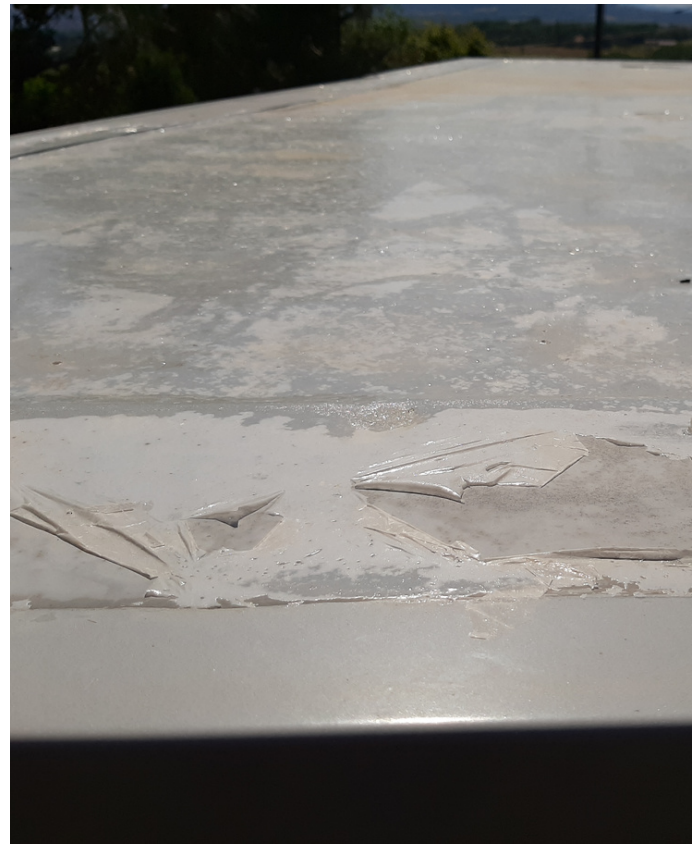
PEELING/ DELAMINATION BETWEEN COATS

Coating is peeling or de-bonding between layers of coating.

Coating was not applied within 24 hours of the previous coat.

Surface Moisture: In many cases, moisture may develop over the first coat overnight

Surface was contaminated by water, humidity, oil, grease, or dust.

1. Remove all loose, peeling, or un-bonded material.
2. Sand surface.
3. Vacuum surface to remove any dust or debris left by sanding.
4. Apply MICROSEALER-50 at a consumption of 50-60gr/m².
5. Reapply coating as specified and according to ALCHIMICA® recommendations.

1. Clean surface of any contaminants and dry prior to coating. Vacuum or mop any water or dust. Remove oil or grease. Surface must be completely dry before applying next coat.

2. Vacuum surface to remove any dust or debris left over from sanding.
3. Apply MICROSEALER-50 at a consumption of 50-60gr/m².
4. Reapply coating as specified and according to ALCHIMICA® recommendations

Beyond Recoat Window: Each coat must be applied within 24 hours of the previous coat.

Surface Contamination: Check substrate carefully before applying coating. Remove any existing contaminants.

Surface Moisture: Prior to applying subsequent coats, always check for moisture on the surface. Especially in cases where morning dew is expected.

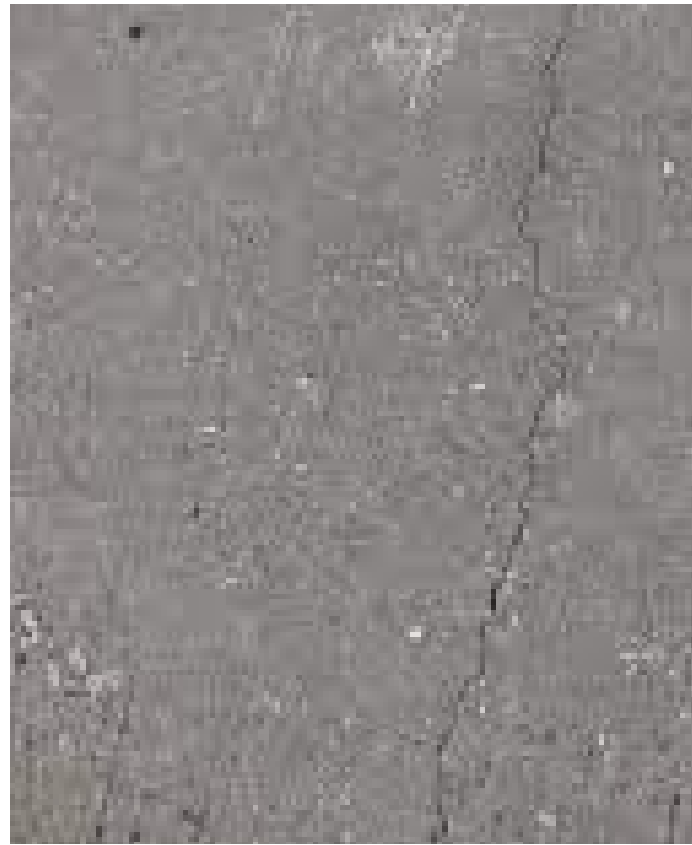
CRACKS

Cracks in the concrete substrate may come through the coating and become clearly visible. Over time, these cracks may increase in number as well as in size.

Substrate cracks are caused by shifting and settling of the structure after original construction.

Concrete structures continually experience expansion and contraction due to temperatures, moisture and loads.

1. Route the cracks at a minimum of 5mm and vacuum well to remove any dust particles.
2. Fill with HYPERSEAL-EXPERT-150® or other ALCHIMICA® polyurethane sealants. Allow sealant to fully cure.
3. Clean and solvent wipe the repair area, extending to 5-10cm on either side of the crack.
4. Prime the repair area and any exposed concrete using MICROSEALER-50 at consumption of 50-60gr/m².
5. Install a detail coat of the base coat material extending to the primed area on either side of the crack. Optional: Apply base coat material extending on either side of the crack and embed reinforcing fabric into wet coating. Center fabric over the HYPERSEAL sealant and allow it to fully cure. Apply additional base coat material as necessary to fully encapsulate reinforcing fabric.

Prior to application of the coating system, perform proper surface preparation including crack detail using HYPERSEAL® sealants.

Unsound substrates such as unreinforced screeds, bitumen membranes, etc. require the application of the waterproofing system with full surface reinforcement using ALCHIMICA® geotextile products.

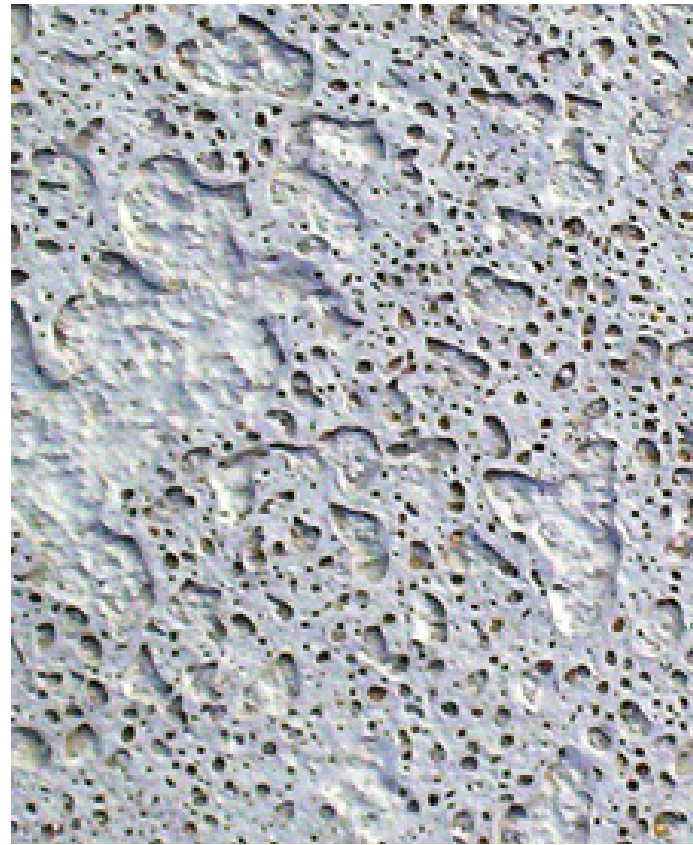
WATER DAMAGE TO UNCURED COATING

Surface has areas of sponge-like, cratered patterns where water has come in contact with uncured coating

Heavy rain or other water source caused damage to uncured coating.

1. Grind all affected areas to eliminate ridges in the cratered areas.
2. Clean and allow to completely dry.
3. Primer the surface using MICRROSEALER-50 at a consumption of 50-60gr/m² and re-apply coating as specified and according to ALCHIMICA® recommendations.
4. In severe situations, the coating may have to be totally removed prior to system re-application.

Do not apply coatings if rain is imminent.

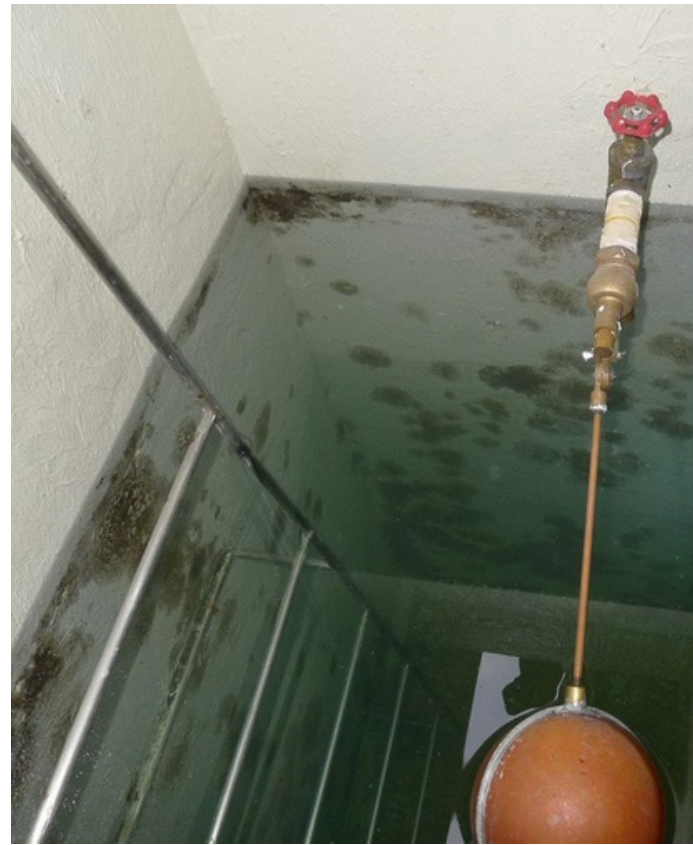
FUNGI FORMATION IN WATER TANKS

Fungi commonly forms in water tank walls.

Fungi formation is expected in aqueous environments when water chlorination does not take place.

1. Remove the water from the water tank and clean the mold using soap and water. Rinse the water tank thoroughly until all soap is removed and refill the water tank.
2. If mold is irremovable:
Grind all affected areas to eliminate ridges in the cratered areas. Clean and allow to completely dry.
Prime the surface using AQUASMART®-DUR/AQUADUR at a consumption of 200gr/m² and re-apply coating as specified and according to ALCHIMICA® recommendations.

In severe situations, the coating may have to be totally removed prior to system re-application.

Water chlorination is mandatory to prevent the formation on fungi in water tanks. Percentage of chlorine in each case is determined by the use of the water and local standards depending on regulations.

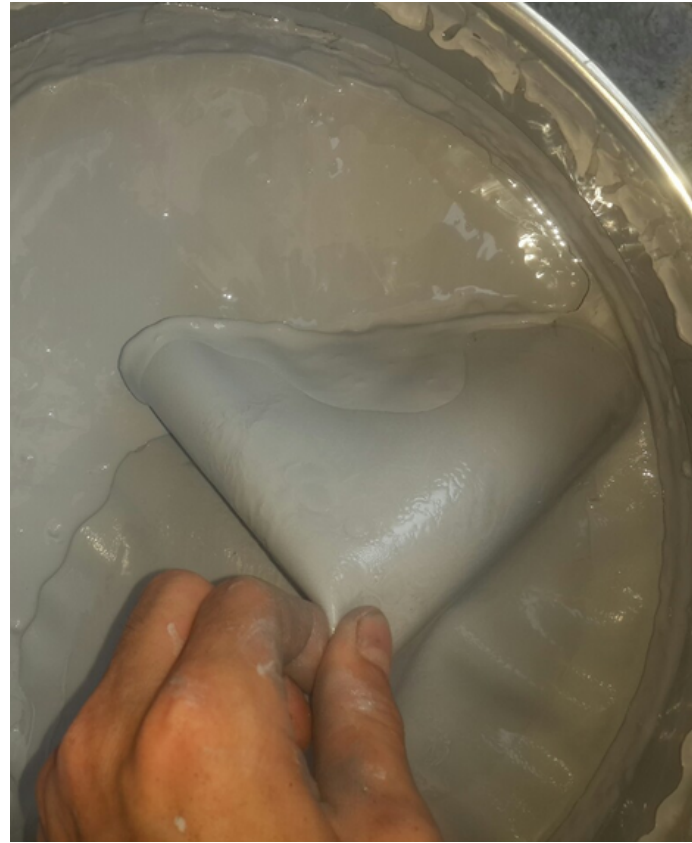
SKIN ON MATERIAL IN CONTAINER

A skin forms on the top of the material in a pail or barrel.

Single-component polyurethane products are moisture-cured. The pail has been damaged during transportation and or storage, allowing moisture to enter the pail, beginning the curing process. This phenomenon can also occur when a pail has been opened but not fully used.

Remove the skin from the top of the product. Note: Be sure to remove all cured material from the container. Do not mix the skin in the product. In case the skin is mixed into the product, it needs to be sieved.

When unsure of transportation or storage conditions, store pails inverted.

Use the entire container of coating material whenever possible.

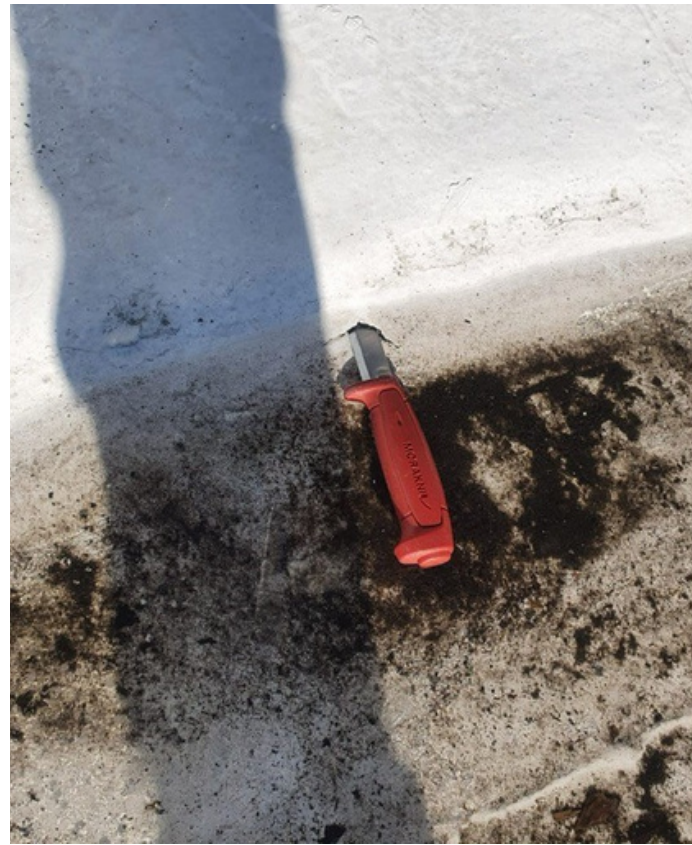
MEMBRANE DAMAGE FROM FOREIGN OBJECTS

Cuts and leaks caused from mechanical damages caused on the waterproofing membrane.

1. Clean the surface around the slit at a perimeter of 10-15cm depending to the tear's length, in order to remove any loose particles, dust, oils etc.
2. Apply MICROSEALER-50 at a consumption of 50-60 gr by overlapping the membrane at the prementioned perimeter.
3. Fill the slit using HYPERSEAL-EXPERT-150, tool it to form a smooth patch and the next day apply the same topcoat that was applied to the rest of the membrane waterproofing system (if one was used) in order to ensure long term UV protection of the patch.

One of the benefits of ALCHIMICA's liquid applied waterproofing systems is the ease of reparations to be carried out when spot problems occur. Nevertheless, it is always recommended to protect the membrane by securing that there are no foreign objects, sharp and heavy ones mostly, that they could fall and damage the membrane, to the best possible extent.
